ACR Guidance Document on MR Safe Practices: 2013

Expert Panel on MR Safety: Emanuel Kanal, MD,^{1*} A. James Barkovich, MD,² Charlotte Bell, MD,³ James P. Borgstede, MD,⁴ William G. Bradley Jr, MD, PhD,⁵ Jerry W. Froelich, MD,⁶ J. Rod Gimbel, MD,⁷ John W. Gosbee, MD,⁸ Ellisa Kuhni-Kaminski, RT,¹ Paul A. Larson, MD,⁹ James W. Lester Jr, MD,¹⁰ John Nyenhuis, PhD,¹¹ Daniel Joe Schaefer, PhD,¹² Elizabeth A. Sebek, RN, BSN,¹ Jeffrey Weinreb, MD,¹³ Bruce L. Wilkoff, MD,¹⁴ Terry O. Woods, PhD,¹⁵ Leonard Lucey, JD,¹⁶ and Dina Hernandez, BSRT¹⁶

Key Words: MR safety; MR; MR safe practices
J. Magn. Reson. Imaging 2013;37:501–530.
 © 2013 Wiley Periodicals, Inc.

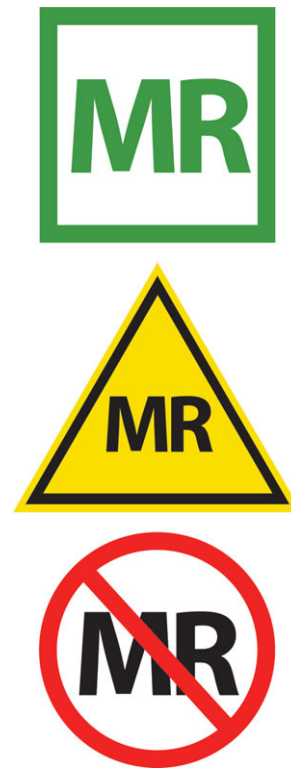
Figure 2. U.S. Food and Drug Administration labeling criteria (developed by ASTM [American Society for Testing and Materials] International) for portable objects taken into Zone IV. Square green “MR safe” label is for wholly nonmetallic objects, triangular yellow label is for objects with “MR conditional” rating, and round red label is for “MR unsafe” objects.

- a. All portable metallic or partially metallic devices that are on or external to the patient (e.g., oxygen cylinders) are to be positively identified in writing as MR Unsafe or, alternatively, MR Safe or MR Conditional in the MR environment before permitting them into Zone III Figure 2. For all device or object screening, verification and positive identification should be in writing. Examples of devices that need to be positively identified include fire extinguishers, oxygen tanks and aneurysm clips.

erly identified and appropriately labeled using the current FDA labeling criteria developed by ASTM International in standard ASTM F2503 (<http://www.astm.org>). Those items which are wholly, nonmetallic should be identified with a square green “MR Safe” label. Items which are clearly ferromagnetic should be identified as “MR Unsafe” and labeled appropriately with the corresponding round red label. Objects with an MR Conditional rating should be affixed with a triangular yellow MR Conditional label before being brought into the scan room/Zone IV.
